Human Impact on the Headwater Environment in the Uporoto Highlands, Tanzania

Cosmas H. Sokoni¹

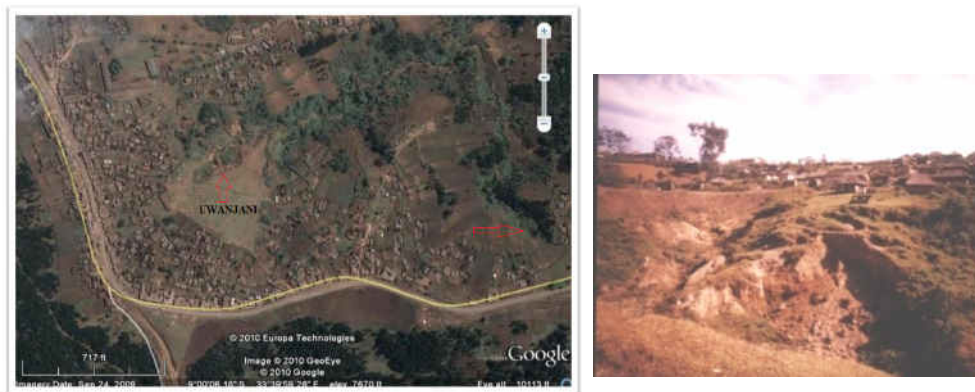
Figure 3: View of Uwanjani gully and built-up areas threatened by gully extension

Gully formation and headward extension have impact on agricultural land and built-up area. The gully extension occurs through slumping of land at the gully head following heavy rainfall. Land suitable for agriculture and settlement development is degraded in the process. Destruction of houses is reported at Kiwanjani area where landslides occurred on the sides of the gully several times (Fig. 3).

The stream gullies also are a threat to infrastructure. A gradual destruction of a bridge at Mwansazi eventually led to a diversion of the road that links Igoma with the Kiwira Forest Plantation station and serves as an outlet for sawn timber that reaches urban markets of Mbeya and Dar es Salaam (Fig. 4). Footpaths joining ridges are abandoned and farmers are forced to use longer routes to reach fields and neighbours. Gully erosion has gradually reduced the size of the football ground at Uwanjani (a 'natural stadium' as villagers could watch games from their homes) that has eventually been abandoned as it became too small and more risky to players (Fig. 3 above).

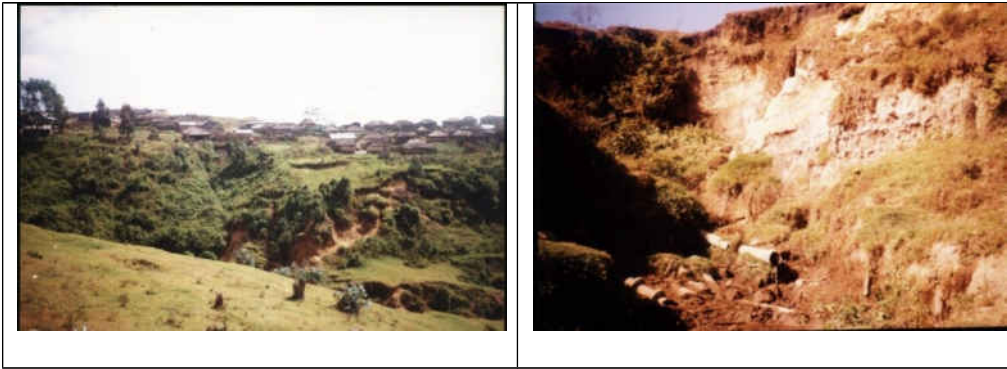
Plates 1 & 2: Gully extension into built up areas and structures for water collection

The distance from heads of gullies to built-up areas decreases though gradually, at Uwanjani, Kwa Yuda, Nzumba, Machinjioni and Mwantaji sites (Plate 1). At Uwanjani, the gully is only 60 meters from the local government office building. Although the village has piped water supply since 1999, some

villagers still rely on gullies for water because piped water supply is erratic and water tapes are located far from the homesteads. Slumping of gully head structure destructs the structures constructed for drawing water (Plate 2) making it difficult for women and children to fetch water.

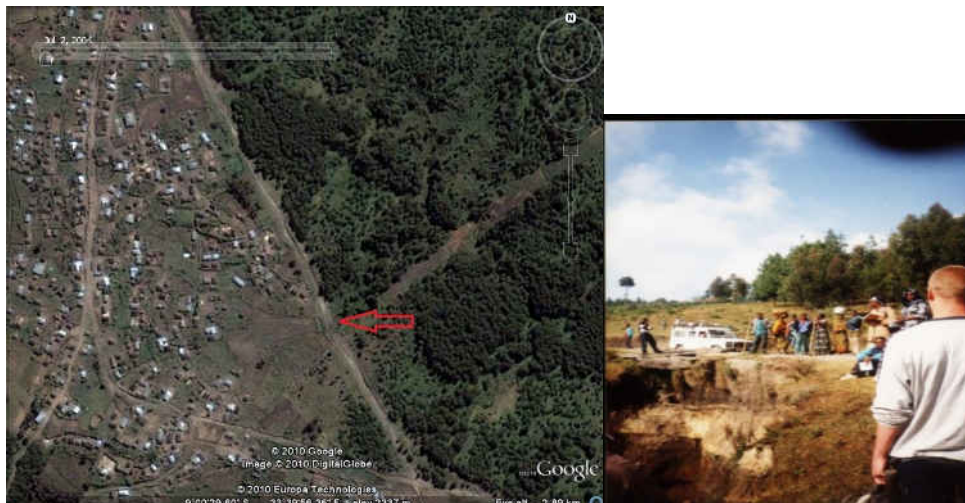
Figure 4: Road diversion after bridge destruction by gully extension at Mwansazi
